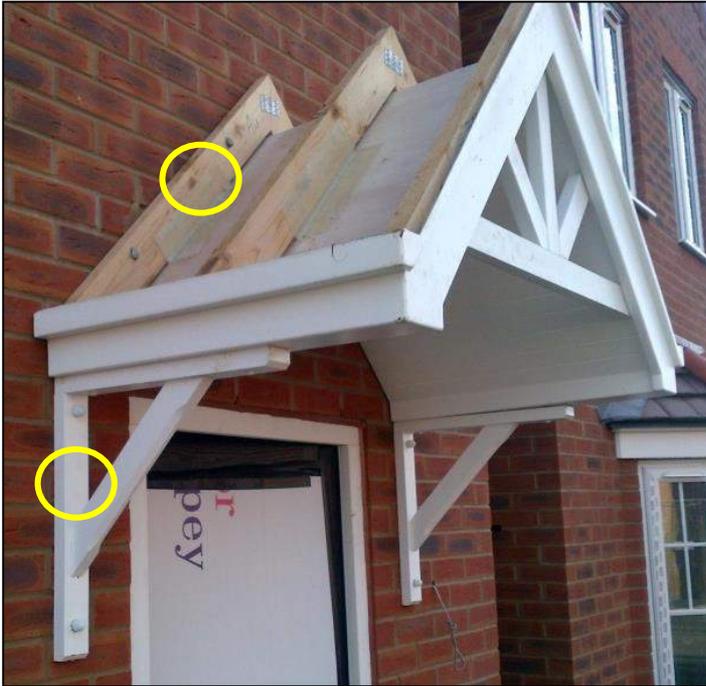
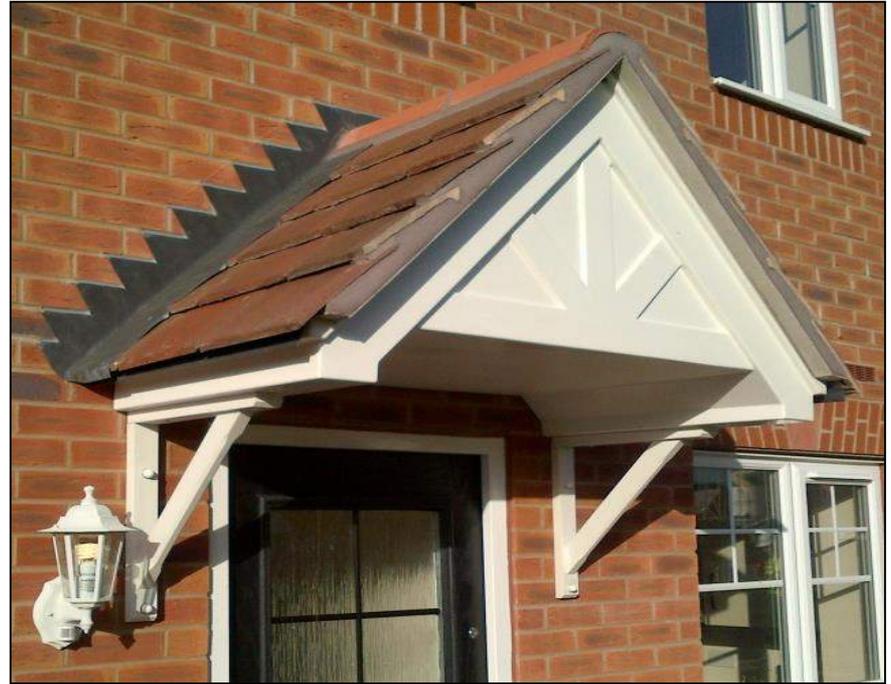
Bracket Supported Tiled Porches

- Fixing to have been considered in the design
- Information to be held by Site Manager and Installer

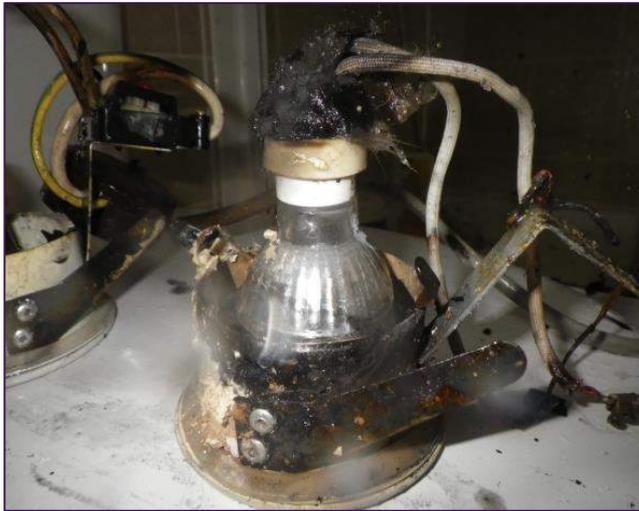
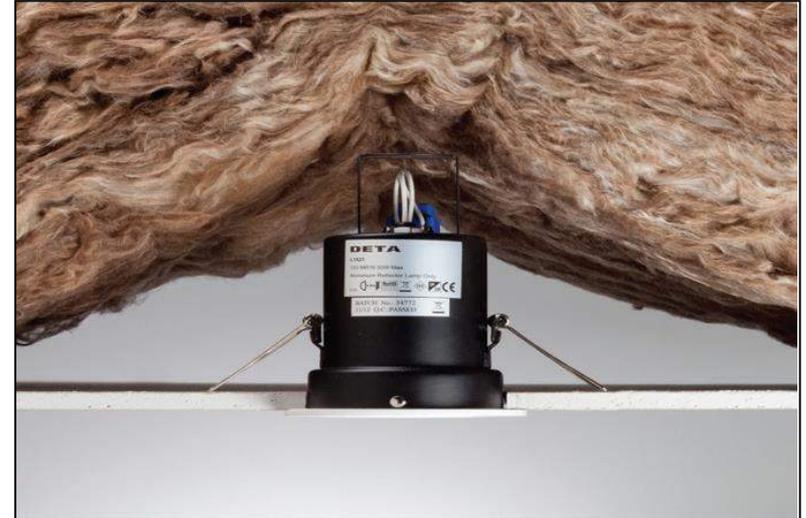
Downlighters

- Insulation Separator
- 4.5w LED Bulb (low heat)
- 6 light fittings operated from one switch [if under the 2013 regulations]

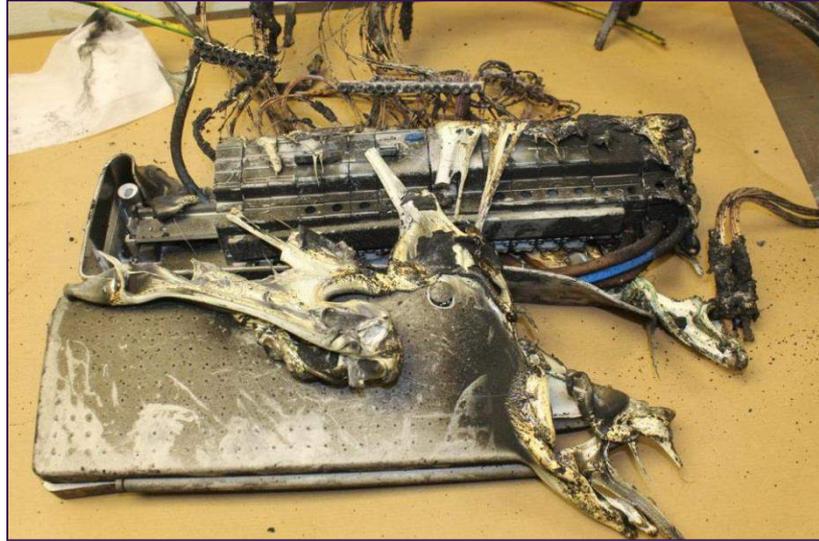
- Problem identified - loose connections (vibration / heat build-up)
- Excessive heat in plastic boxes can cause ignition / fire
 - Reinforce controls with installers
 - Introduction of metal encased units – July 2015

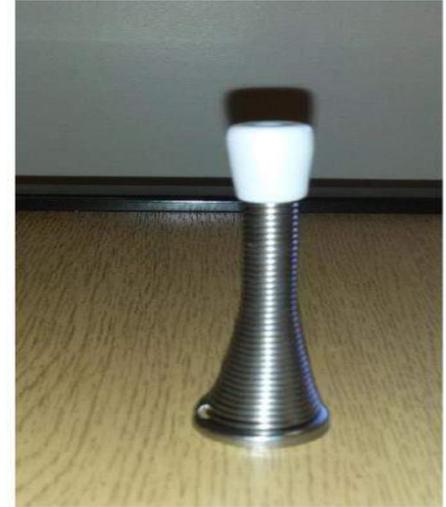
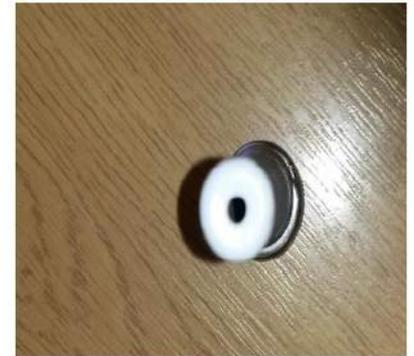
- Small child removed white plastic cap from 'sprung nickel plated door stop'. Swallowed it - almost choking.
- New specification - deeper end cap (more difficult to remove) and air hole to allow continued breathing.
