# Scottish House Builders H&S Forum

## Asbestos Contaminated Land

**Prof Roger Willey**

**ACS Physical Risk Control Ltd**

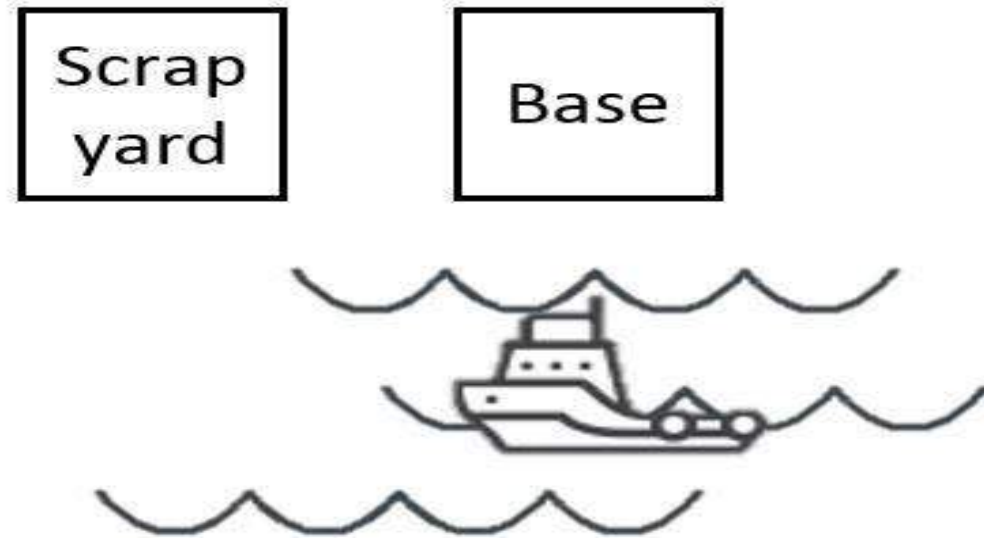
Figure 1

- Site heavily contaminated: asbestos, heavy metals, etc

- approx. 100 000 m<sup>3</sup> contaminated land

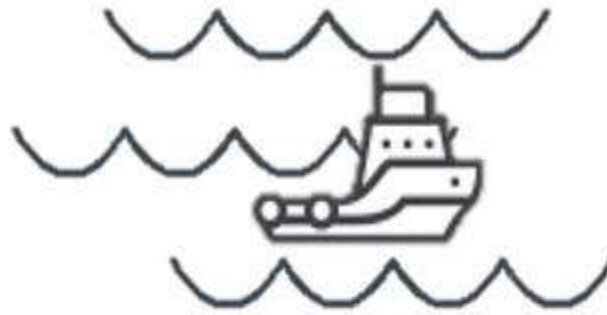
Figure 2

- Establish two zones

Dirty Zone	Clean Zone
---------------	---------------

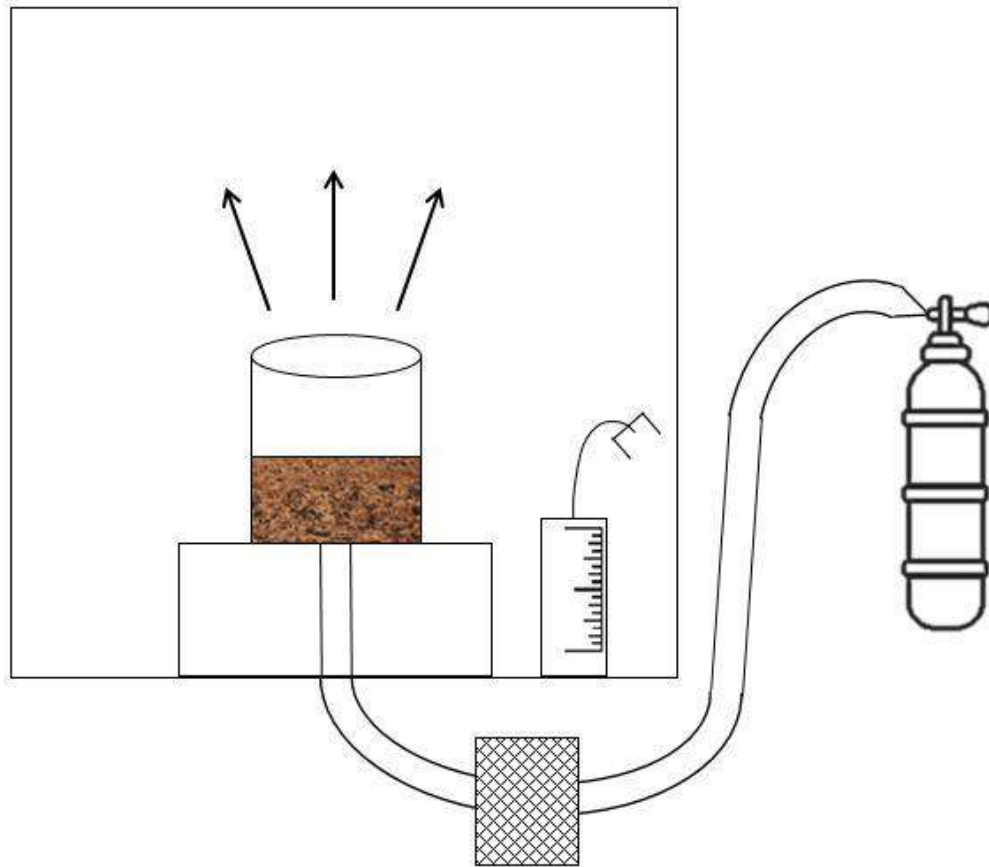
Figure 3

# No. 1 Relate f/ml to cont. level

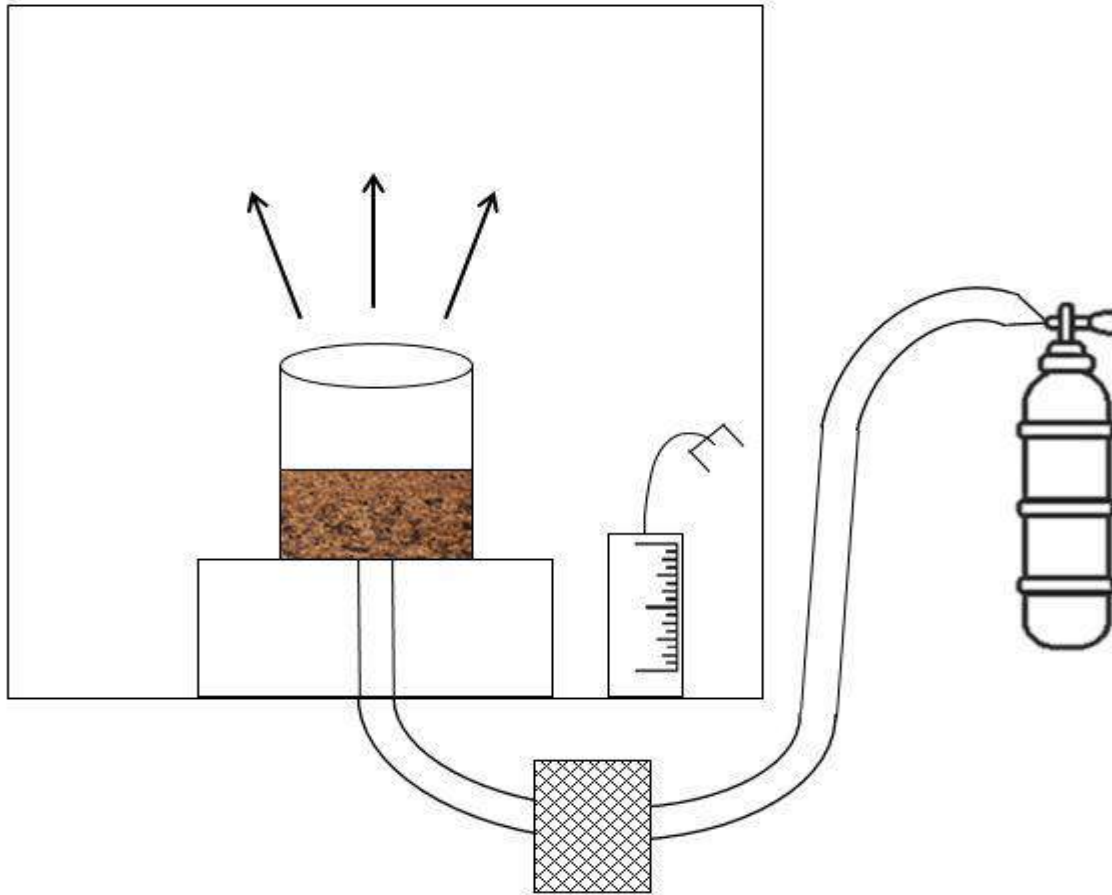
Figure 5

## No. 2 Relate $f/m_l$ and water in soil

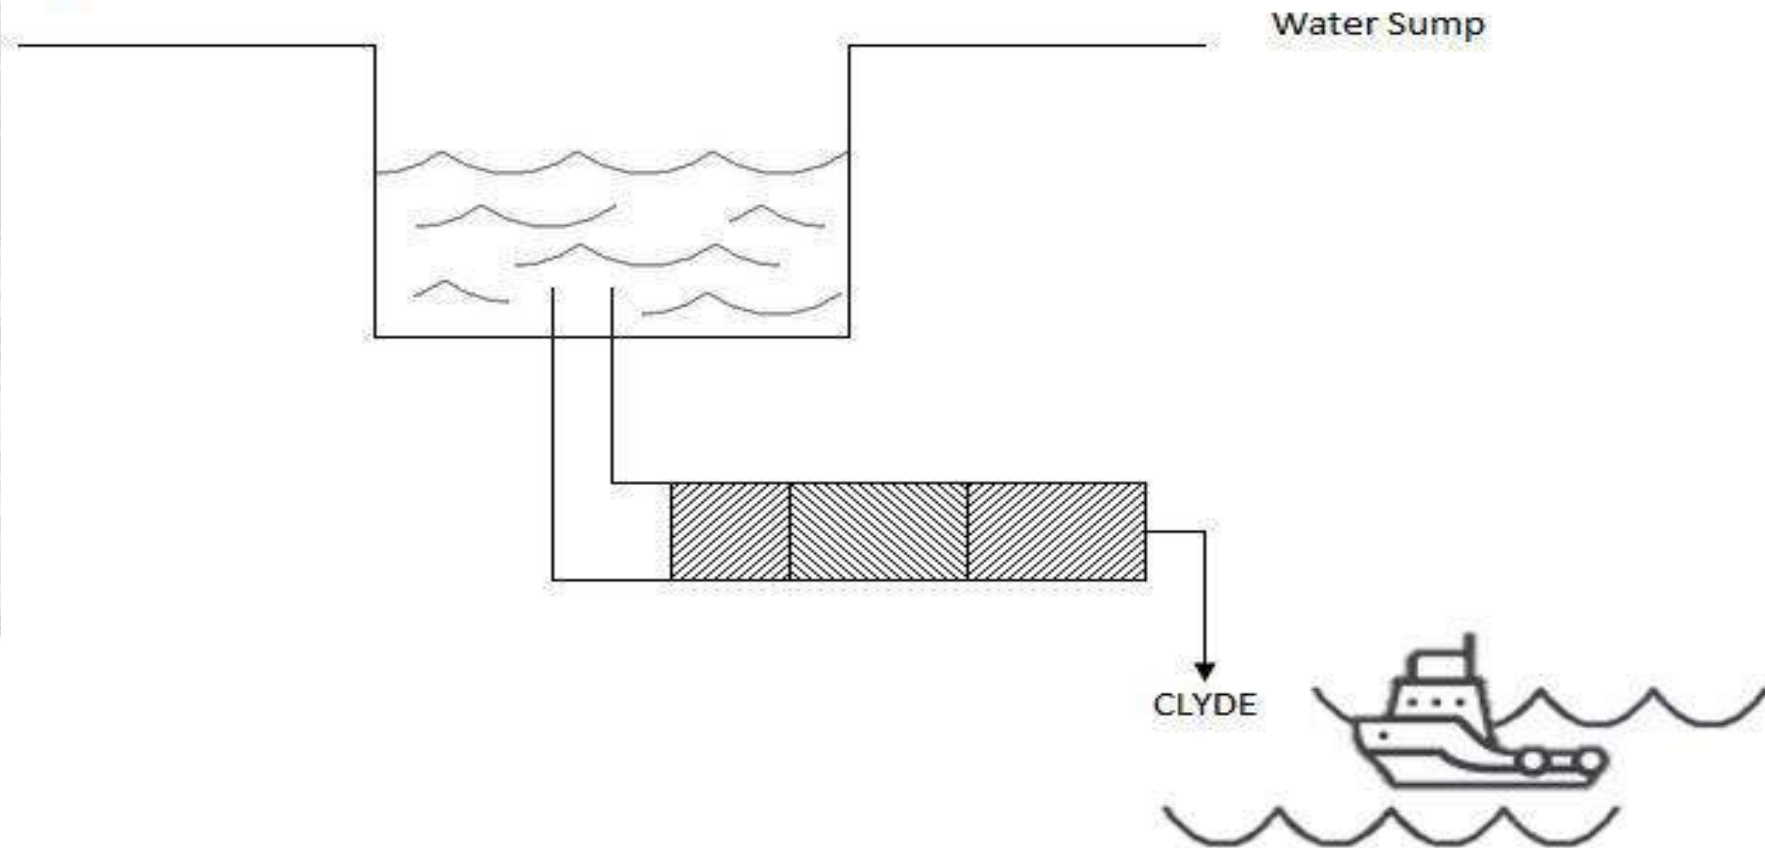
Figure 7

## No. 3 Filtration experiments

- We know how much wt % asbestos in soil will give “negligible risk”.
- If soil level is above this then we know how much water to put in to lower risk.
- We know how to filter the water to minimise risk to the environment.

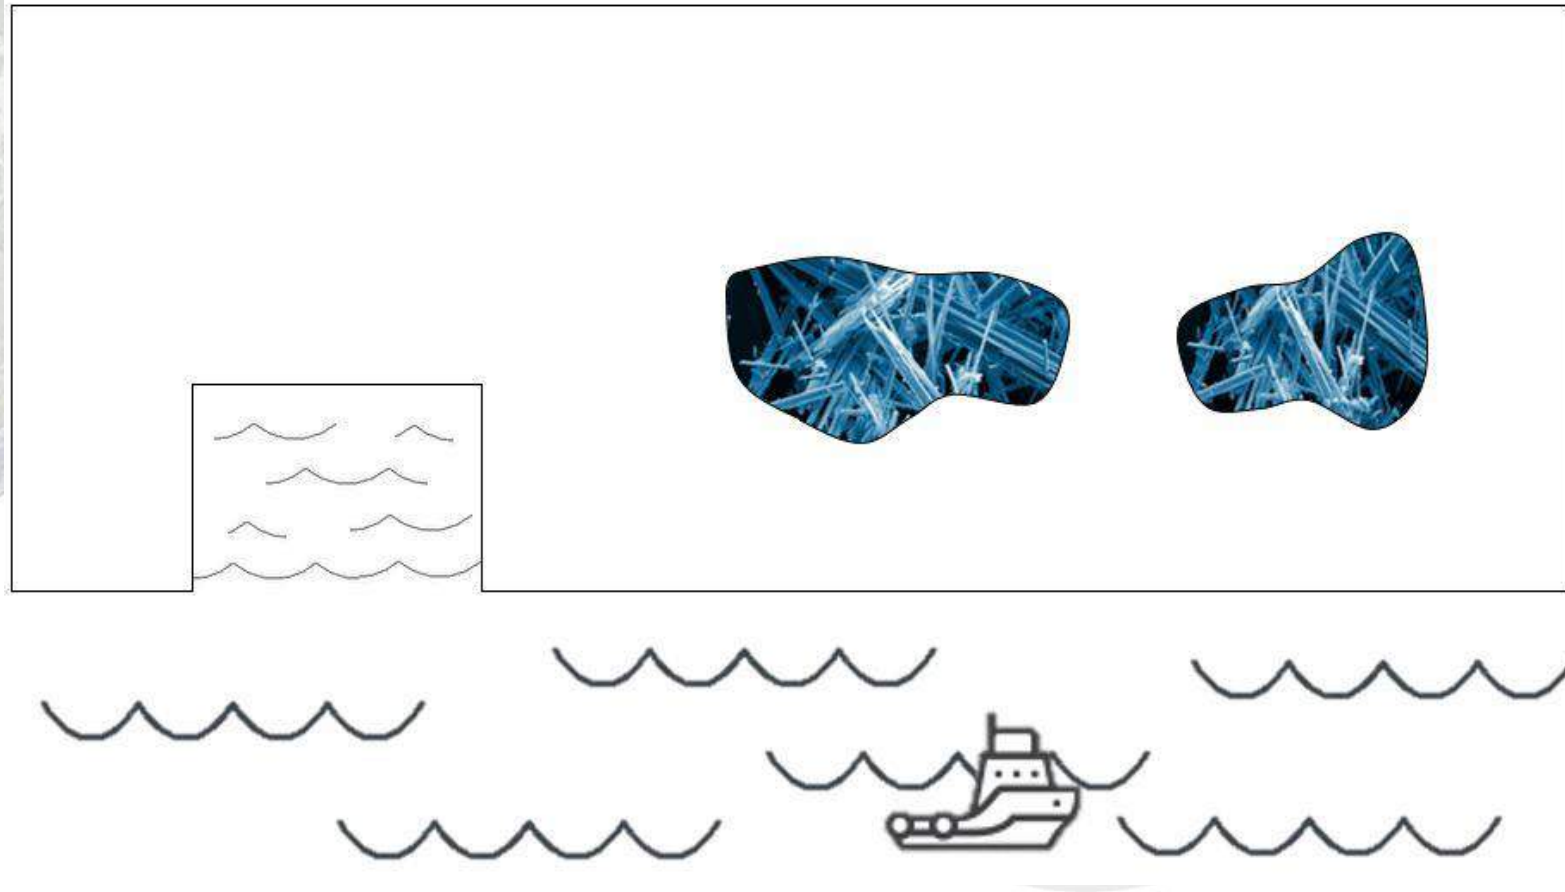
Figure 8

# Largest asbestos tip in Europe

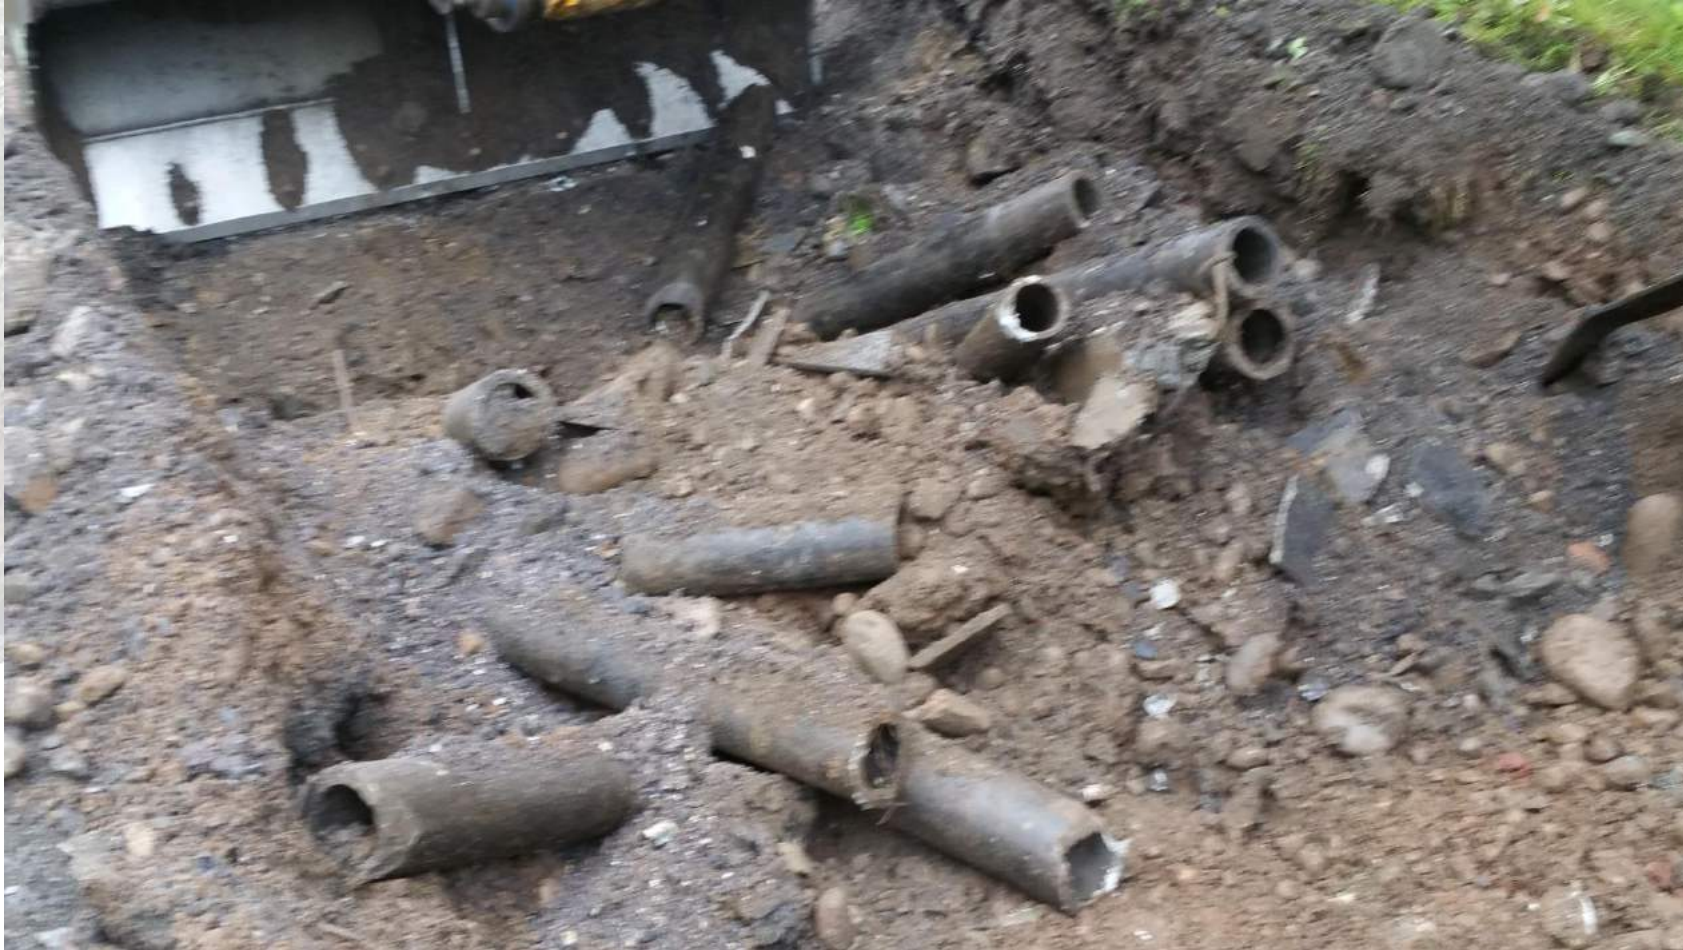
# Buried AC Pipes

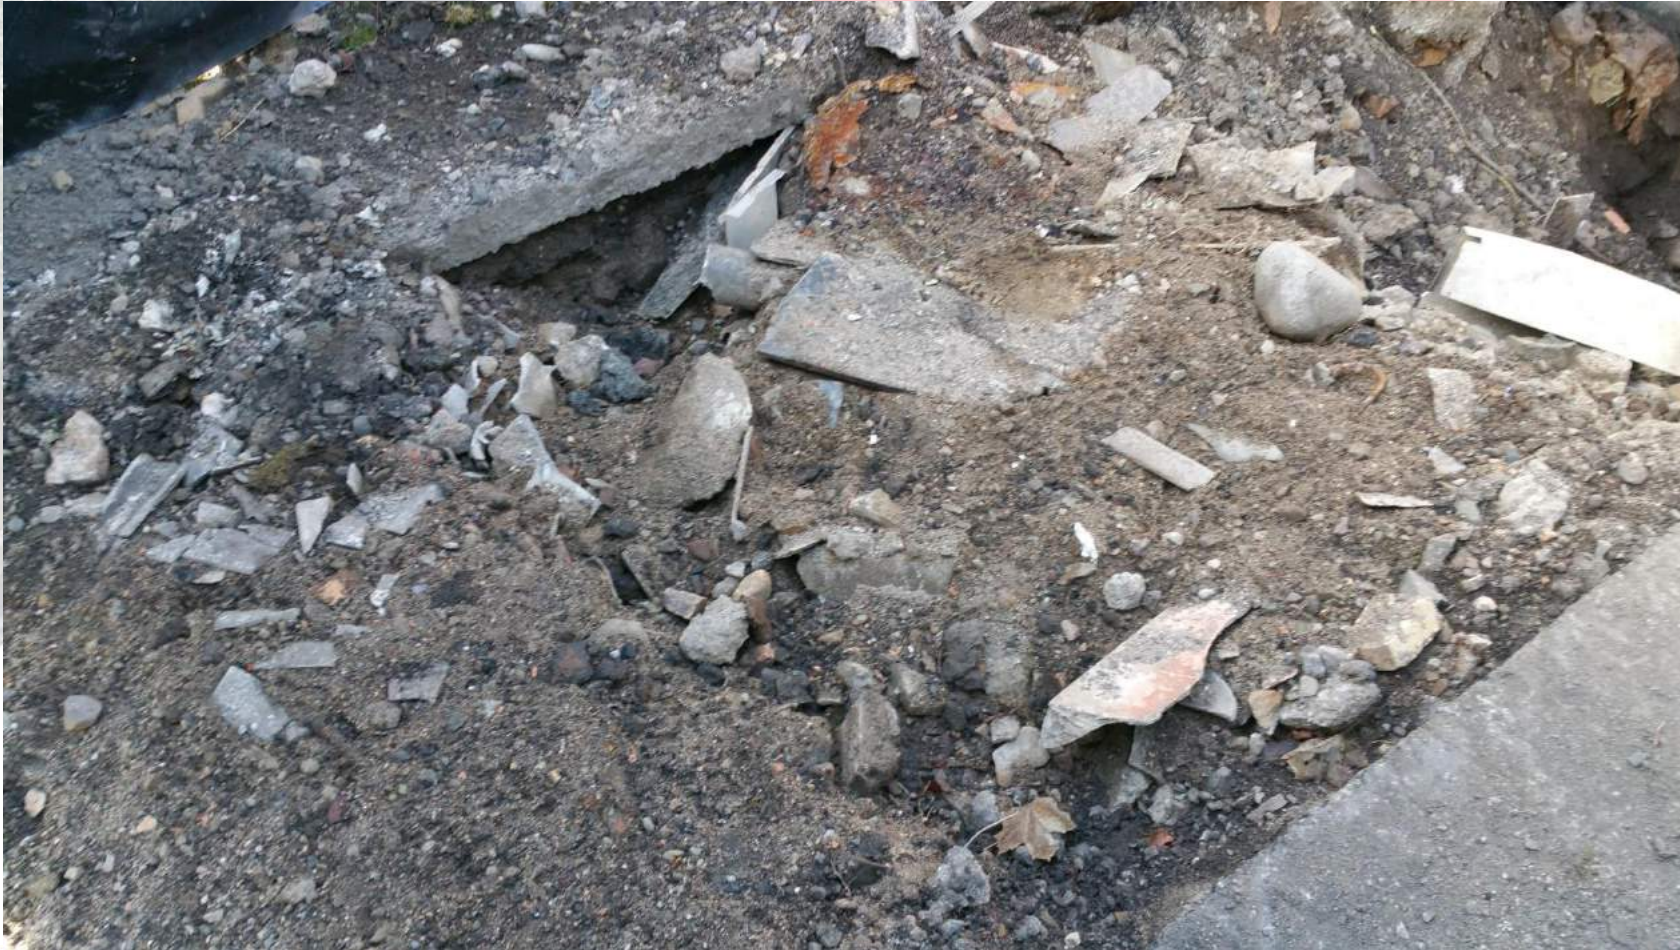
# Buried AC Fragments

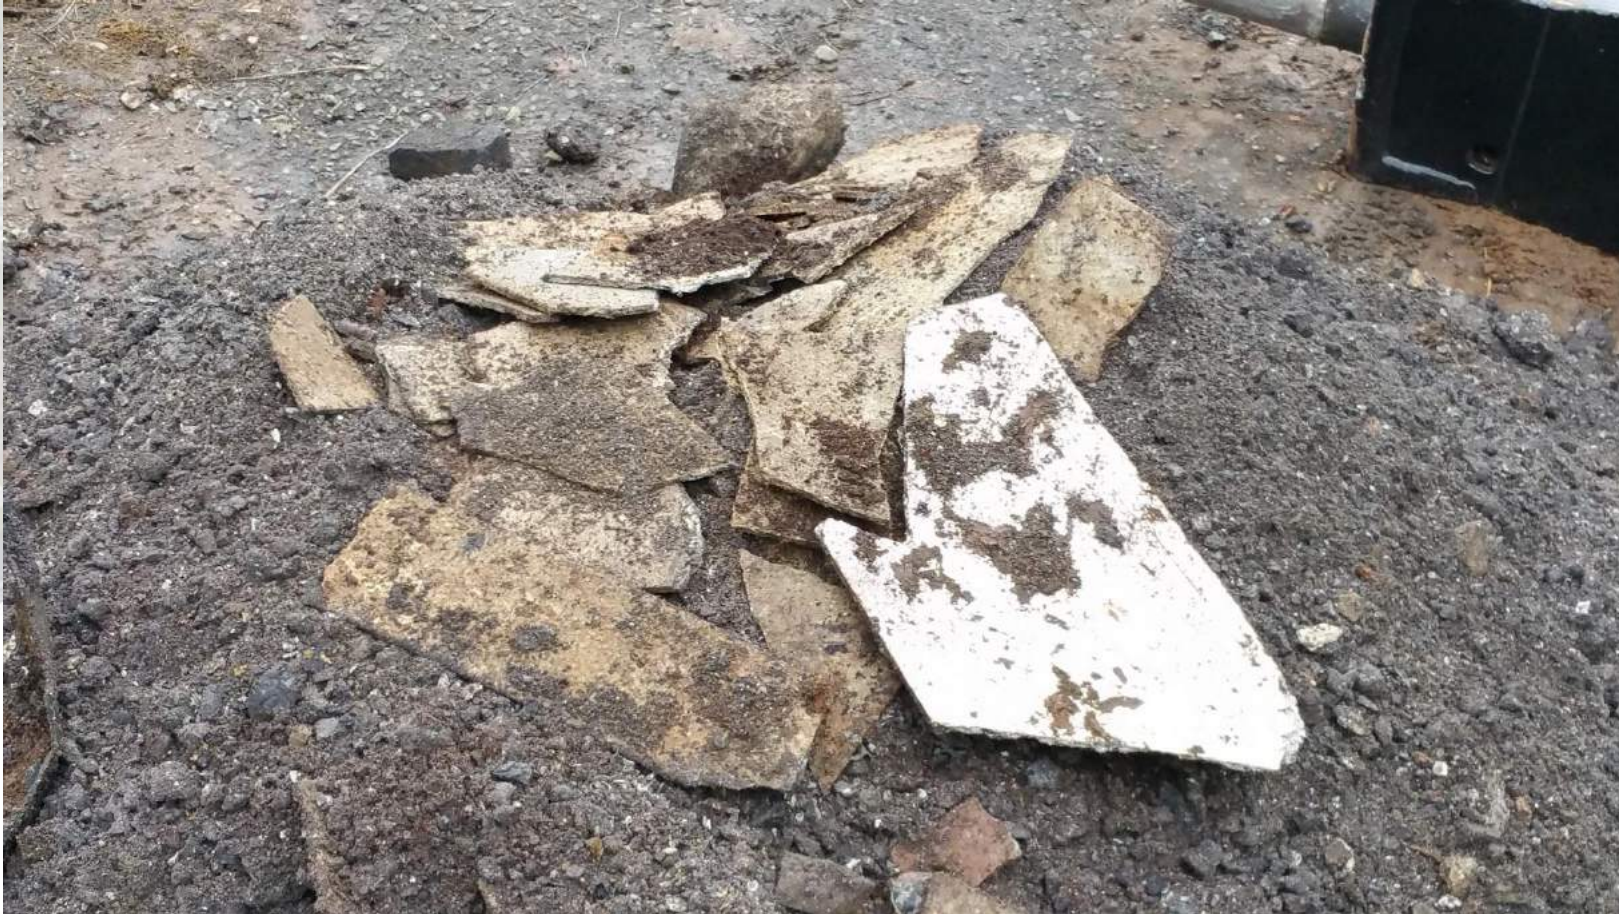
# Fly-Tipped AC and AIB

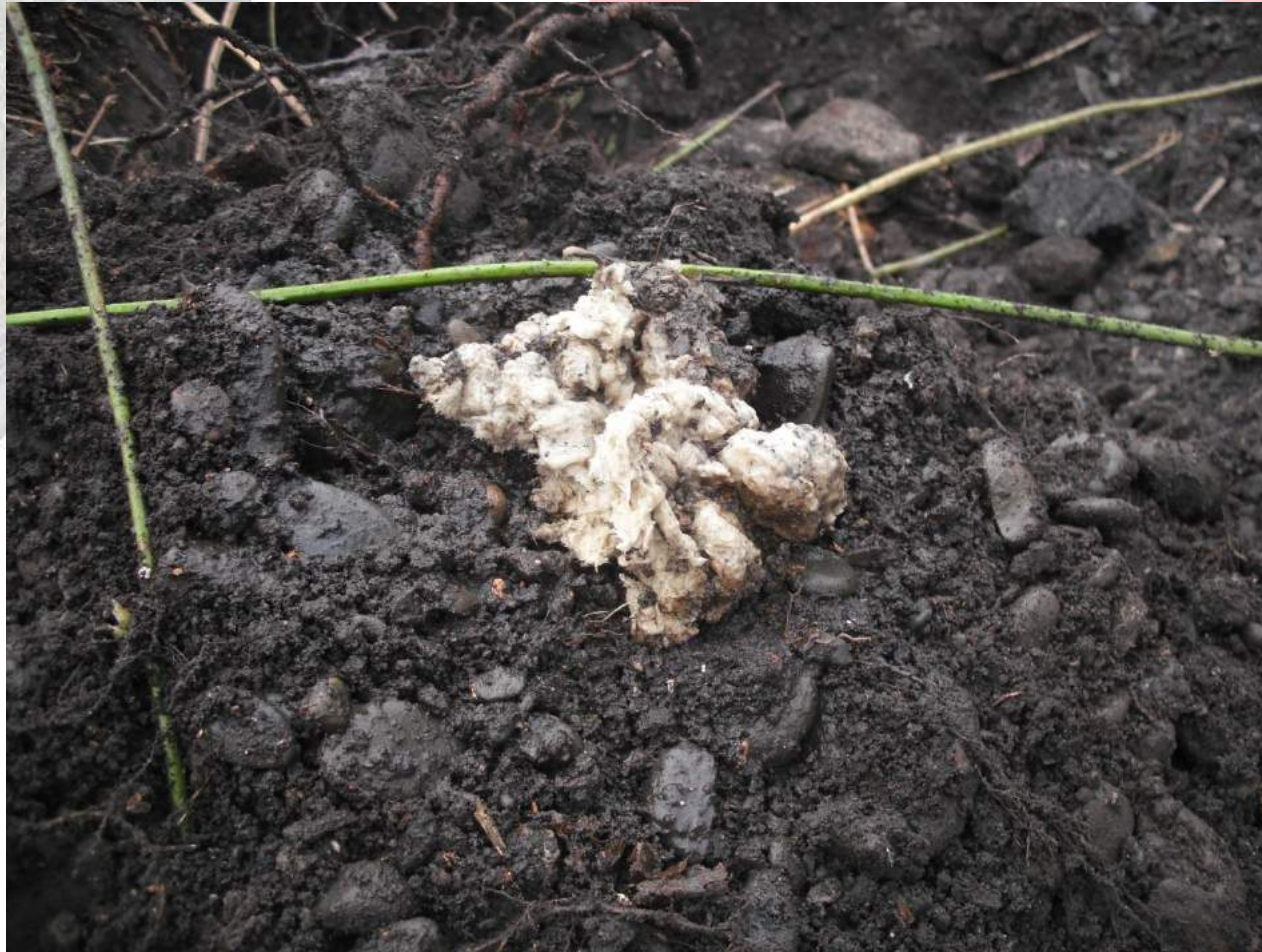
# Buried Asbestos Rope

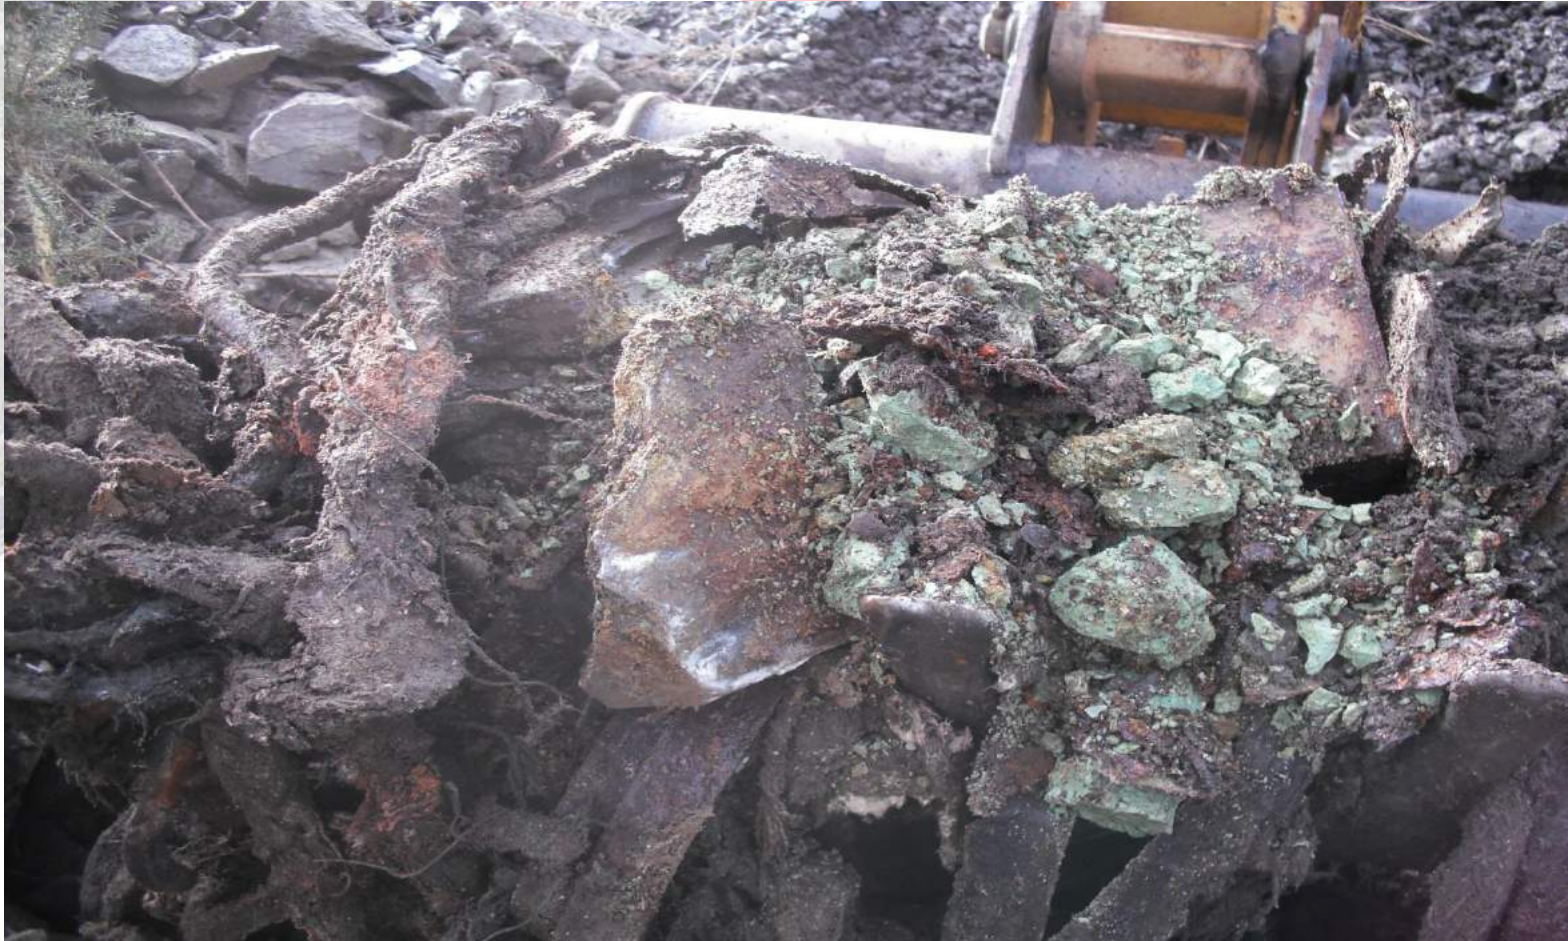
# Buried Asbestos Textile and Raw Insulation (Blue)

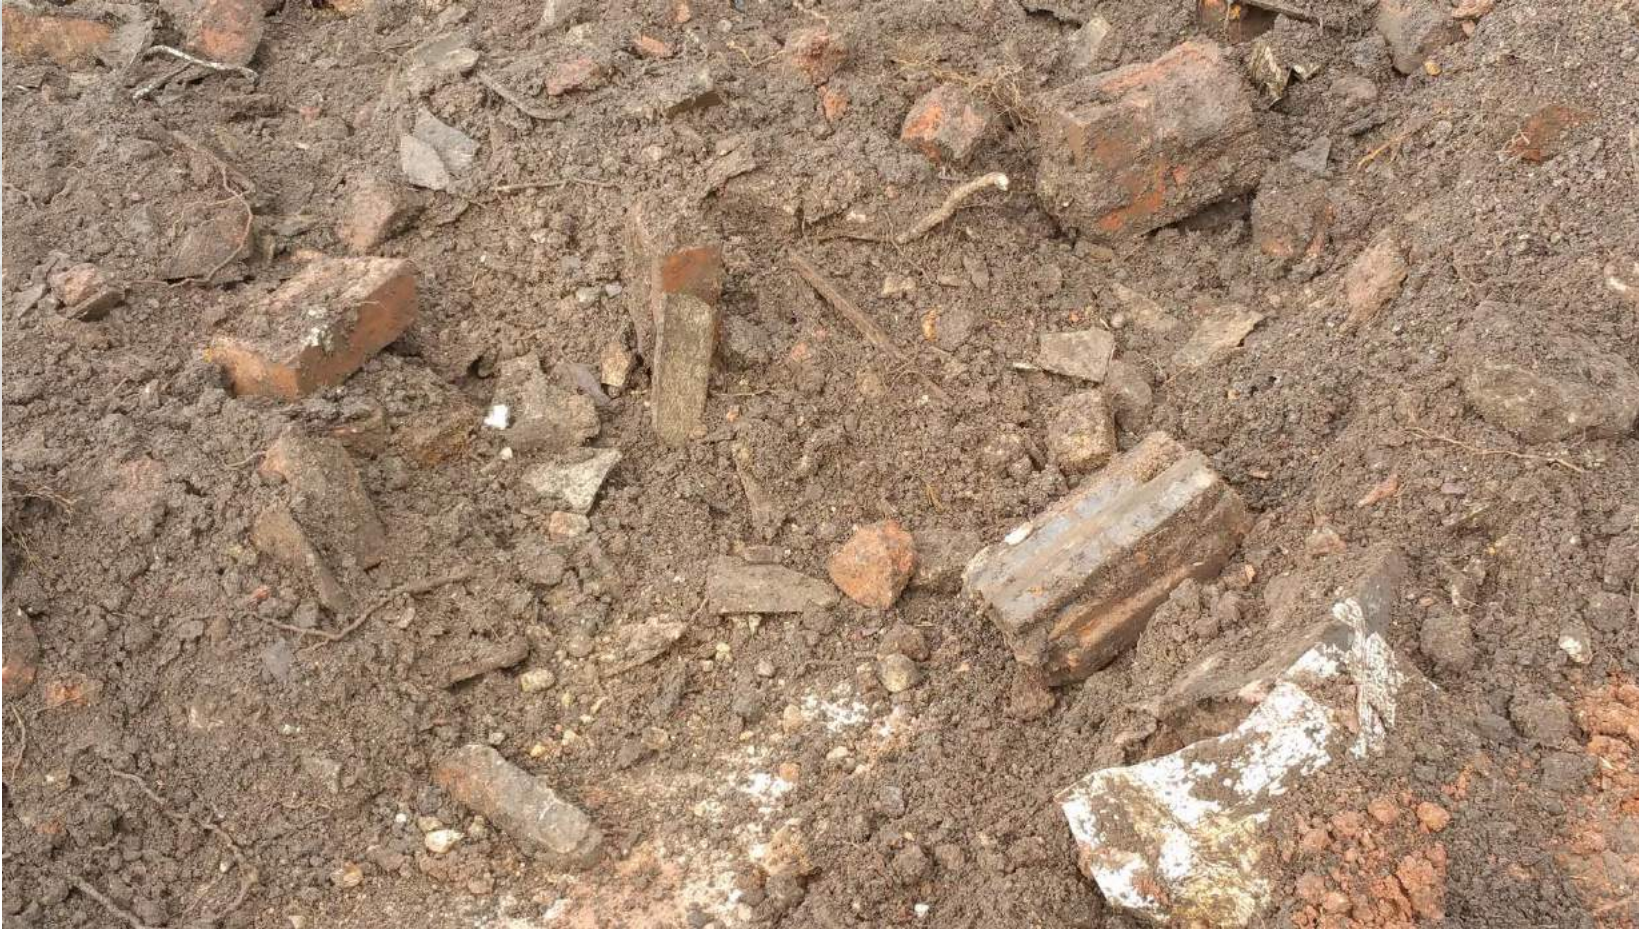
# Made Ground with Loose Asbestos Fibres

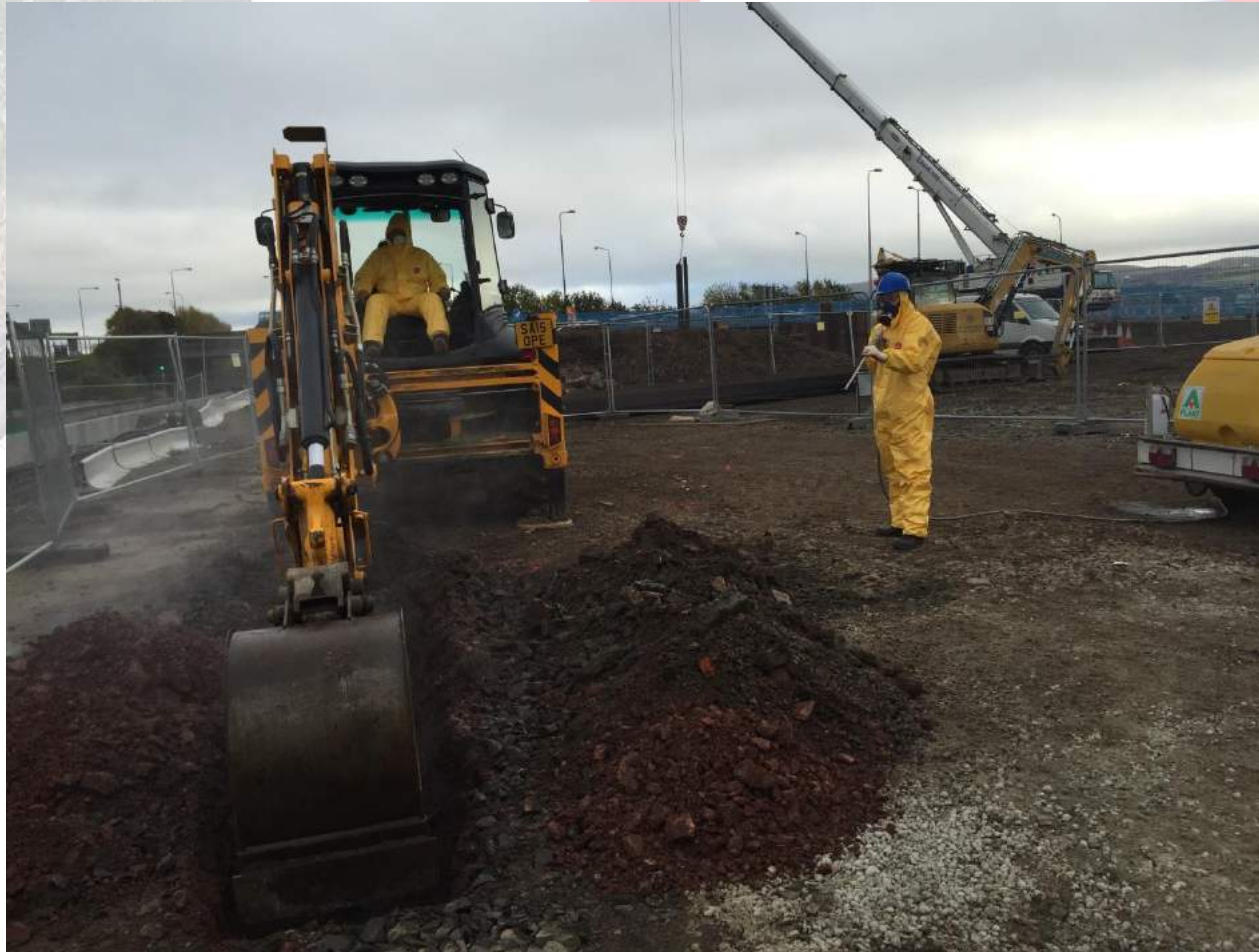
# Asbestos Specific Site Investigation

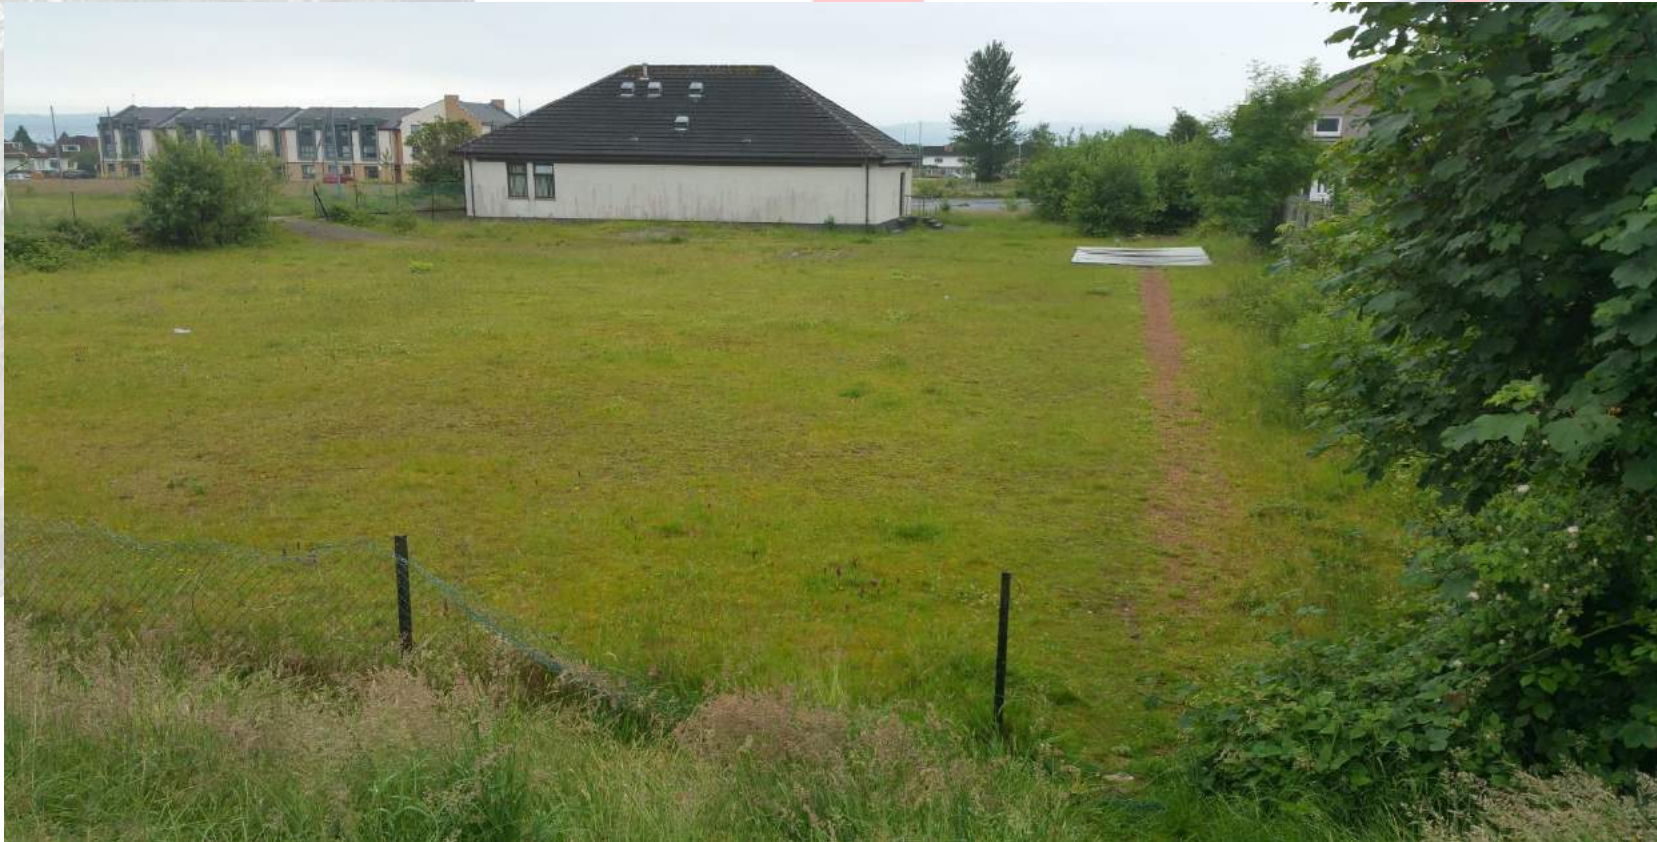
No Remediation – Leave as ‘contaminated land’ and design safe work methods

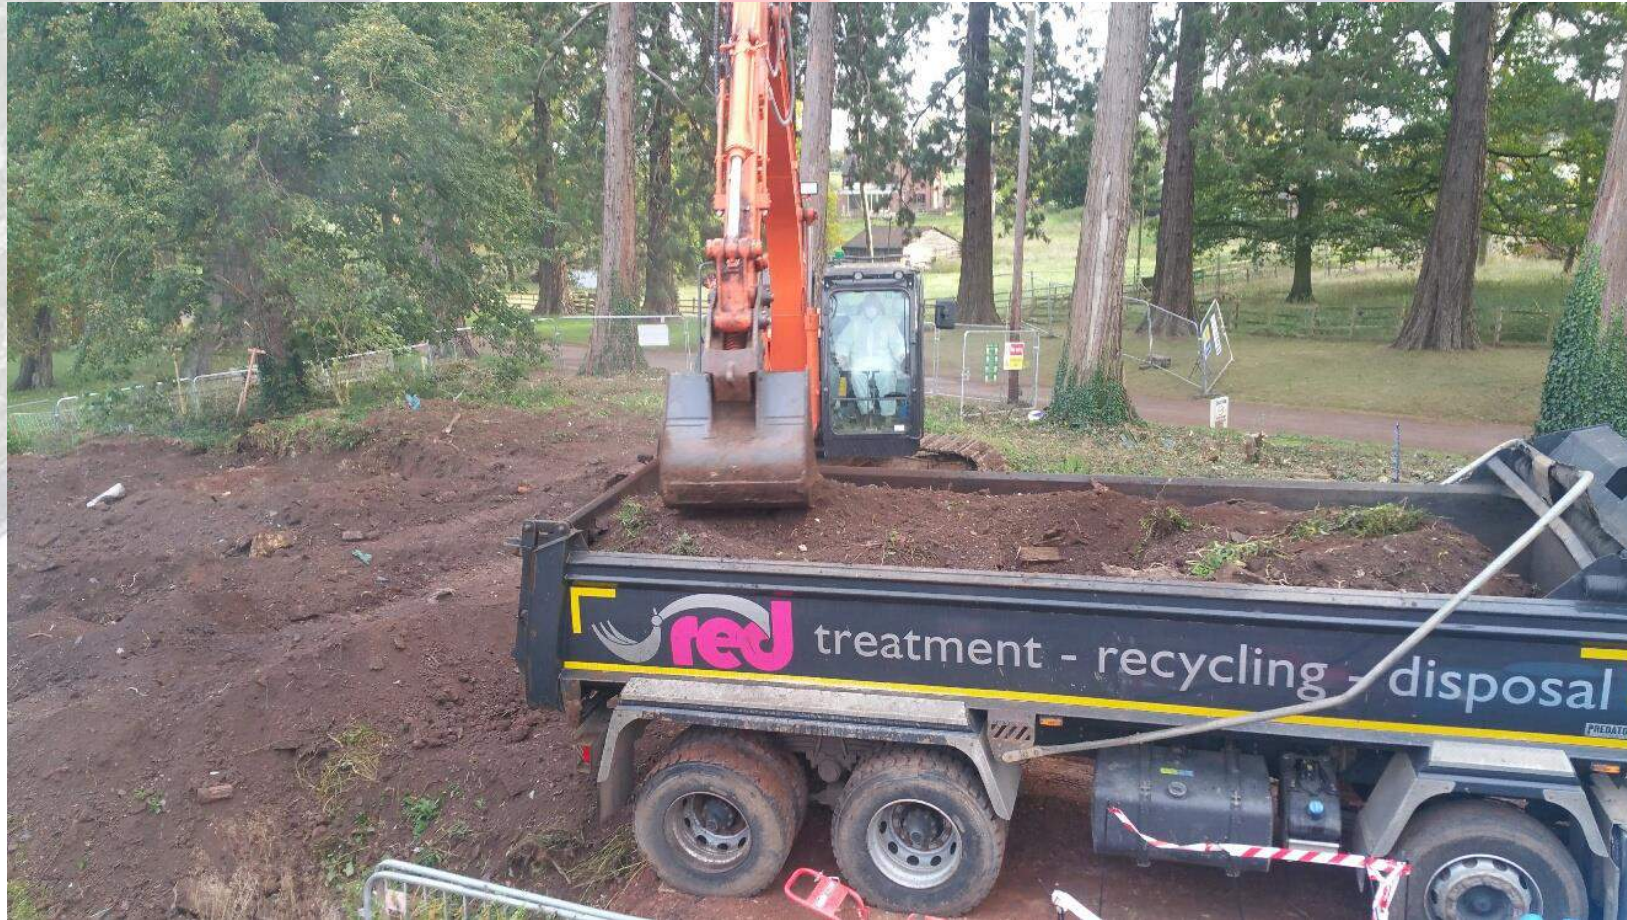
# Remediation by Wholesale Disposal (Special Waste) – Waste Classification Essential

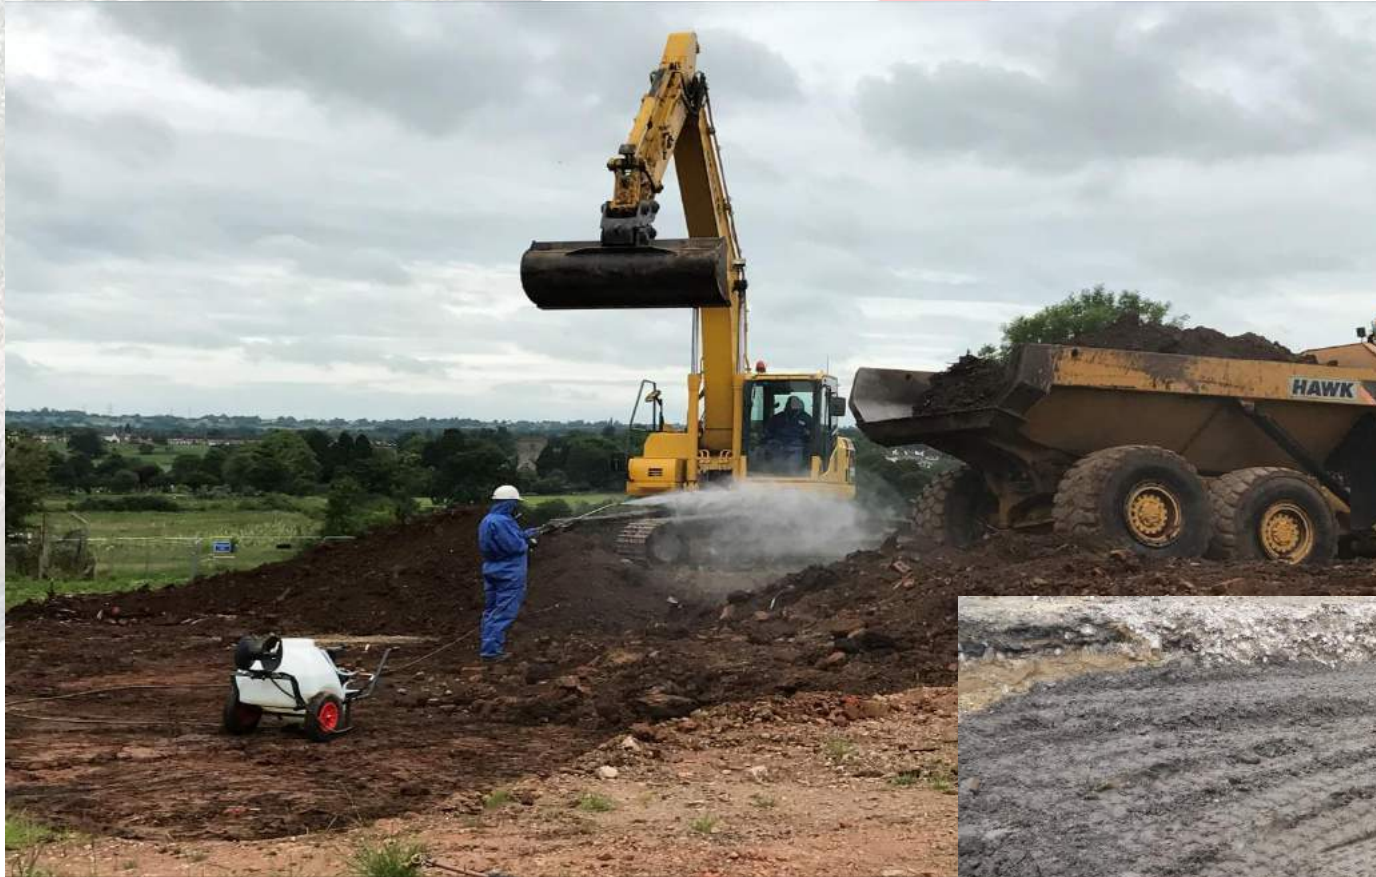
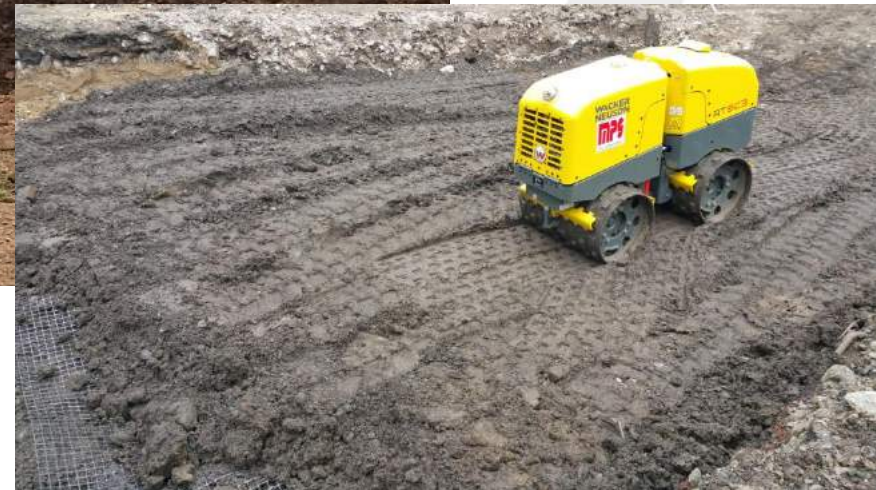
# Remediation by Onsite Relocation and Burial

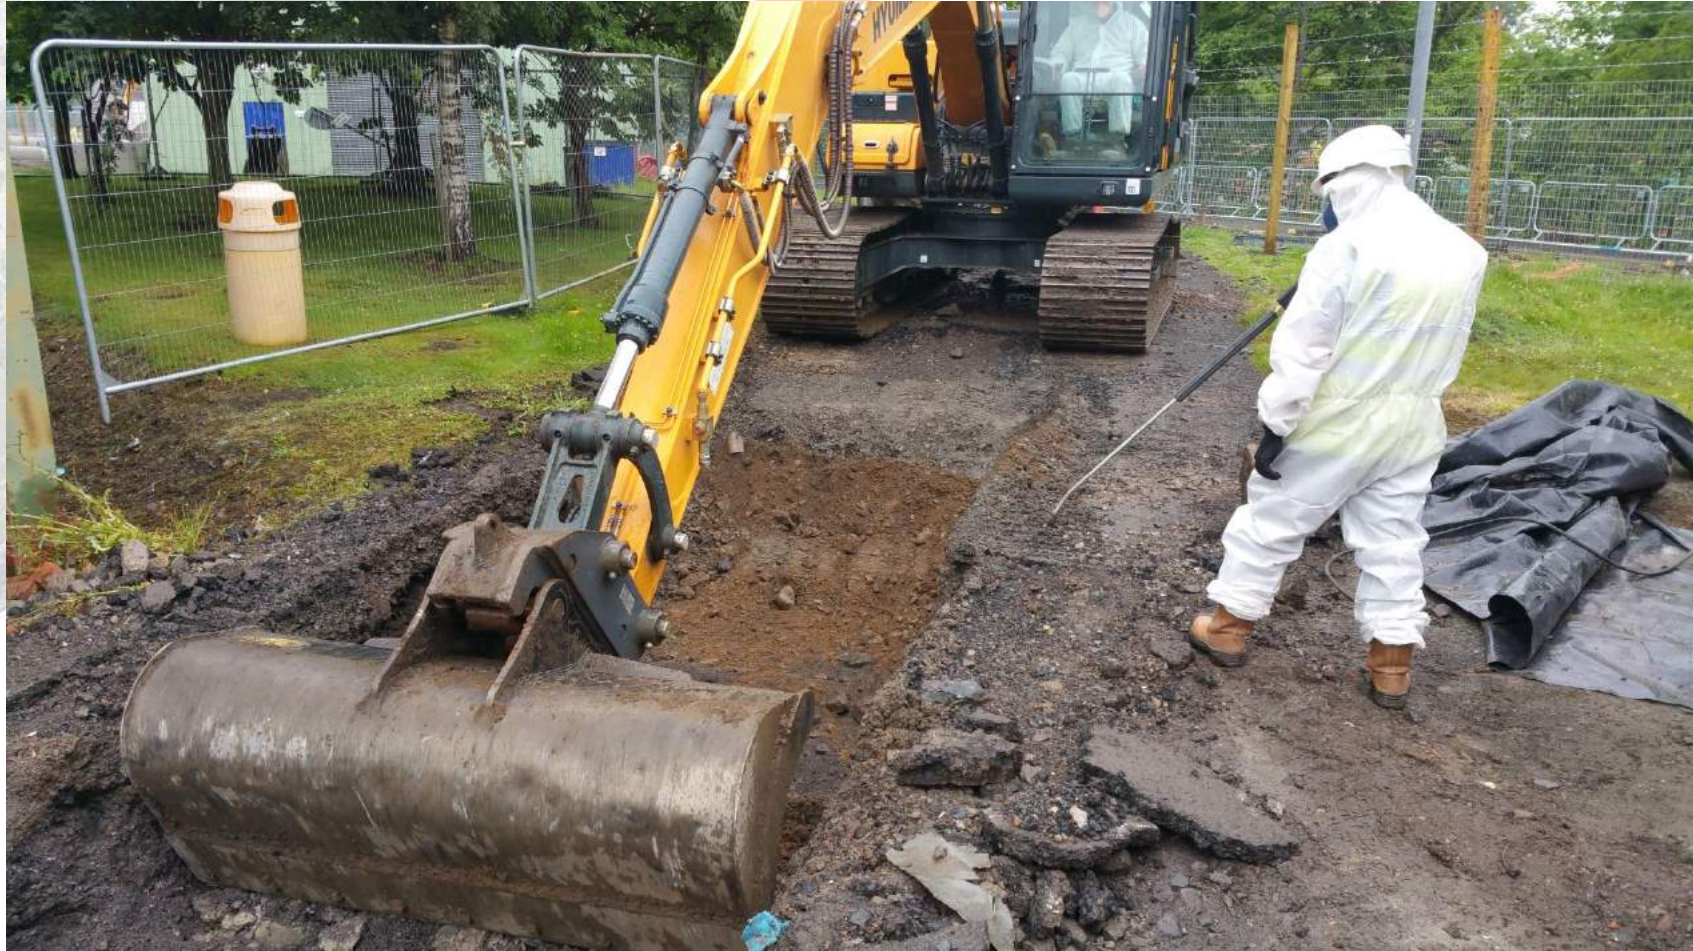
# Remediation by Onsite Capping
