# Scottish House Builders H&S Forum

## Asbestos Contaminated Land

**Prof Roger Willey**

**ACS Physical Risk Control Ltd**

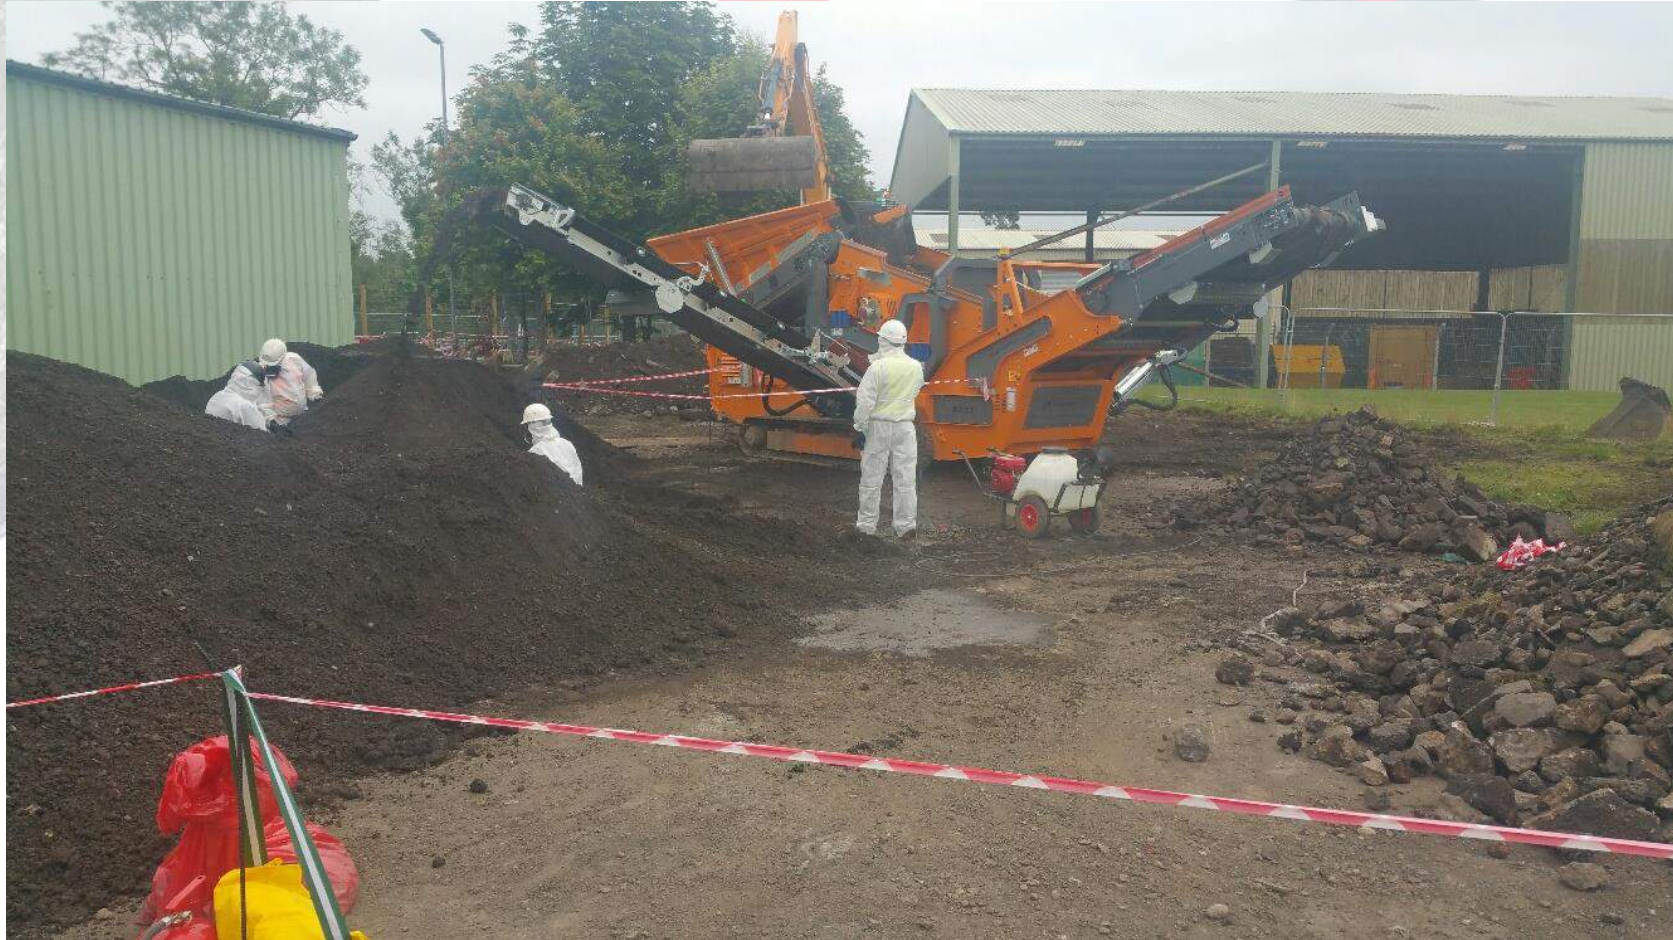
# Remediation by Sorting / Waste Stream Segregation
