Scottish House Builders Health & Safety Forum
1 May 2024

Health & Safety

Roofing battens Safety Alert and Toolbox Talk

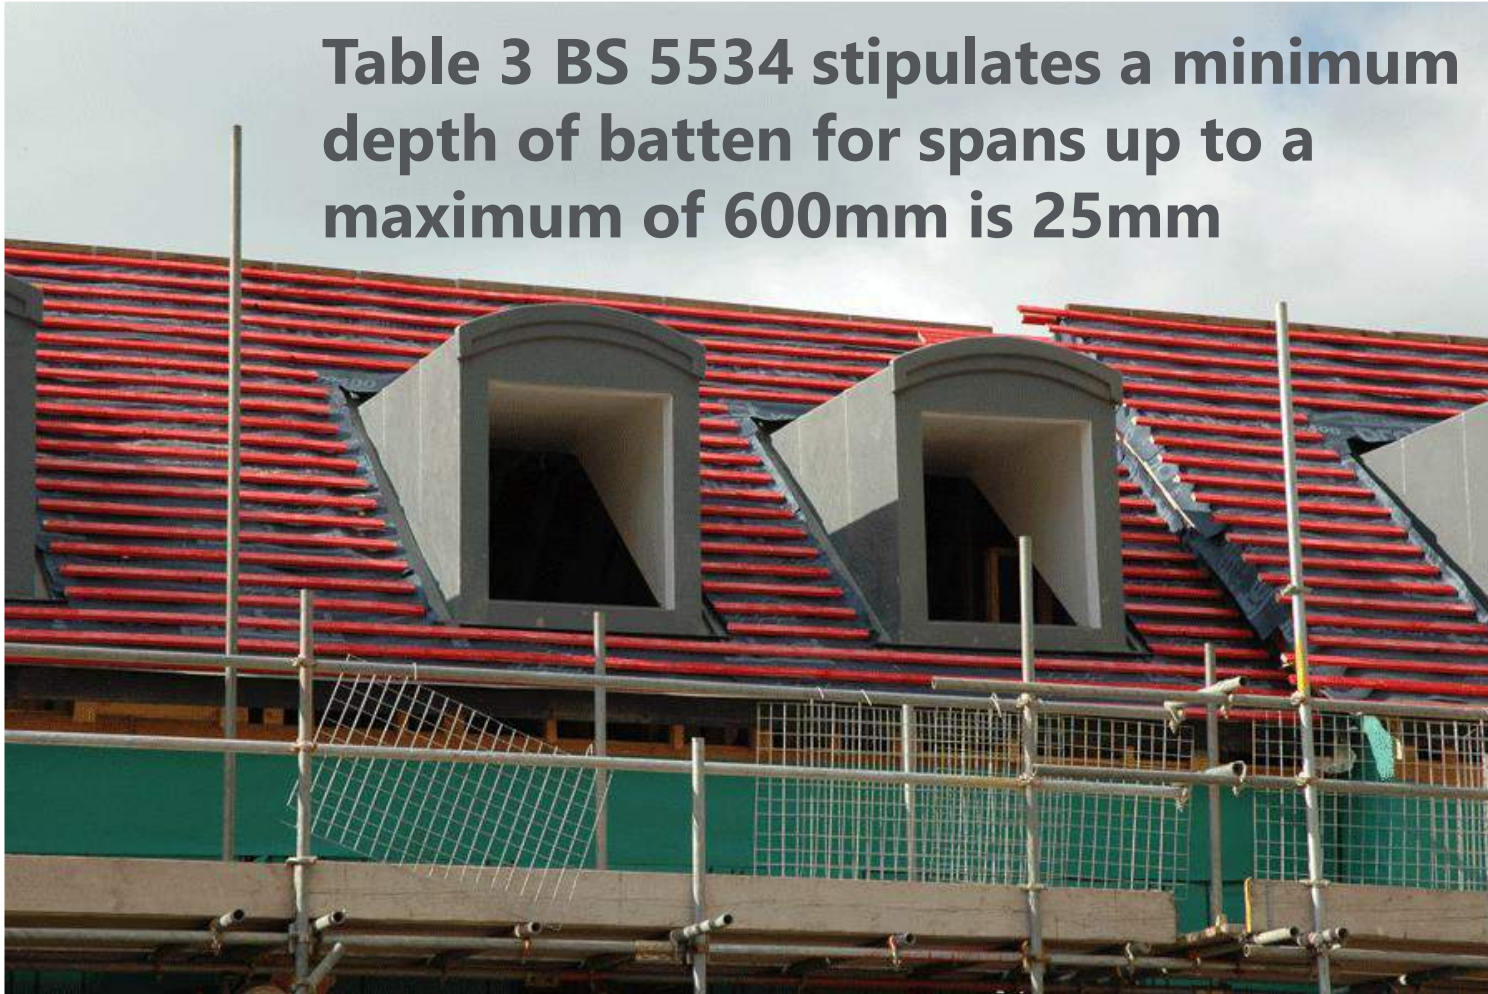
Battens

Table 3 BS 5534 stipulates a minimum depth of batten for spans up to a maximum of 600mm is 25mm

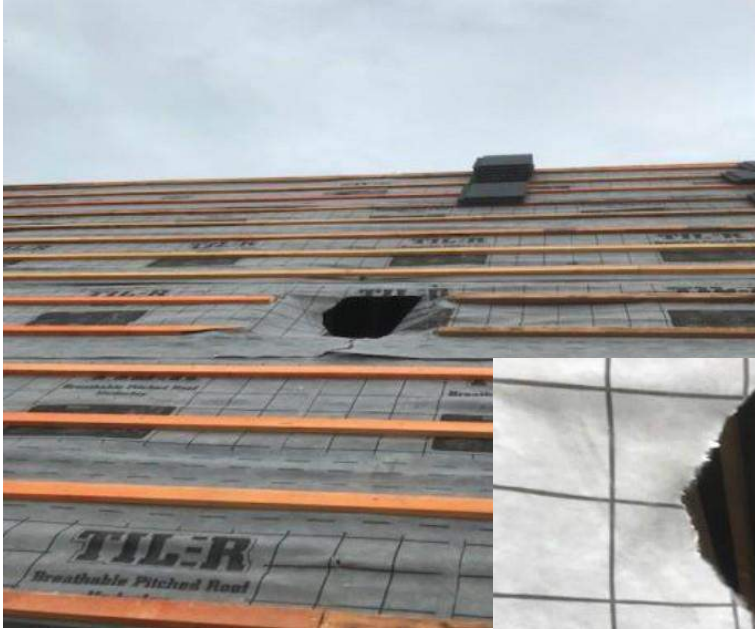
Internal Fall Prevention (IFP)

Internal fall protection requirements for pitched roofs on new build homes

Falls from height remain one of the biggest causes of accidents and fatalities in construction, therefore it is important that the hierarchy of fall protection set out in the Work at Height Regulations 2005 is followed at all times.

Home builders constructing new homes should install internal fall protection to protect the workers installing roof coverings from injuring themselves while working above open roof trusses. Types of internal fall protection include proprietary decking systems or air bags/bear bags as soft-landing systems.

Following an investigation with our members, it was noted that some UK House Builders allow internal fall arrest systems to be removed once the roof is felted and battened; unfortunately though this only addresses one aspect of the risk involved.

Although operatives are instructed and trained to only walk where the tile battens are attached and to place their feet mid-span of the truss to prevent them from falling over. This risk increases further when the roof is being loaded out with roof tiles, because the operative is stood in the upright position along the truss line, while walking up the roof carrying the roof coverings.

In the event that a roof batten broke under the weight of an operative, there is only the strength of the underfelt membrane to prevent the operative falling through into the roof void, and as such the potential risk of injury remains high.

The NFRC therefore recommends that the internal fall protection is not removed by the home builder or main contractor until it is safe to do so; ideally when the roofing works have been completed, but as a minimum when the roof has been felted, battened and completely loaded out.

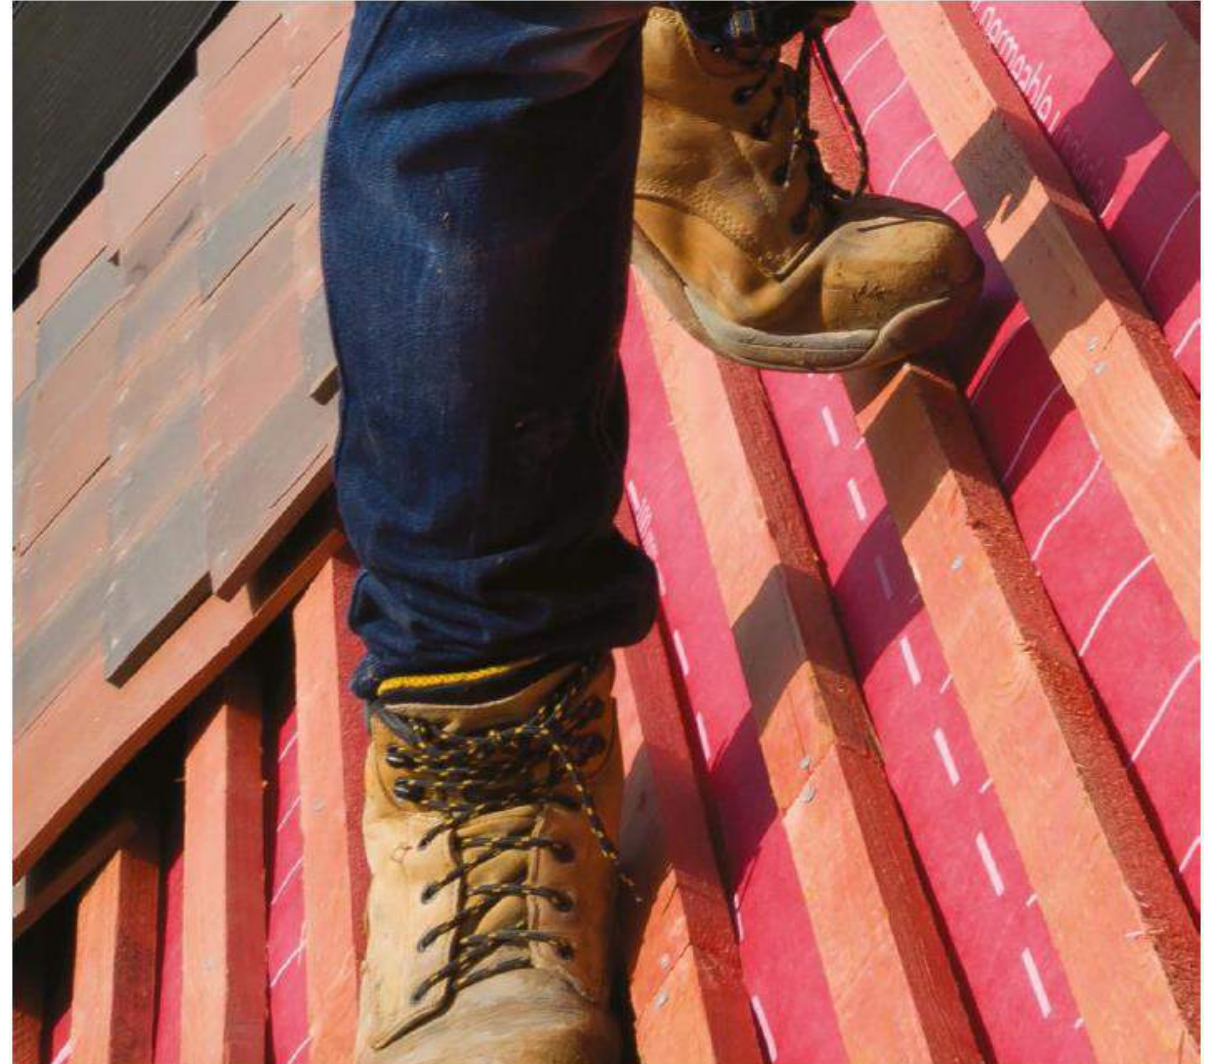
Roofing battens

Step 1
Check the thickness of the battens. 25 mm thick batten should be 25 - 28 mm thick but never less than 25 mm.

Checks can be visual where discrepancies in thicknesses are obvious, or the batten can be measured with a tape measure, ruler or measuring gauge.

Unequal thickness of roofing battens visible in a stack is a sign of substandard battens, which should not be bought or used.

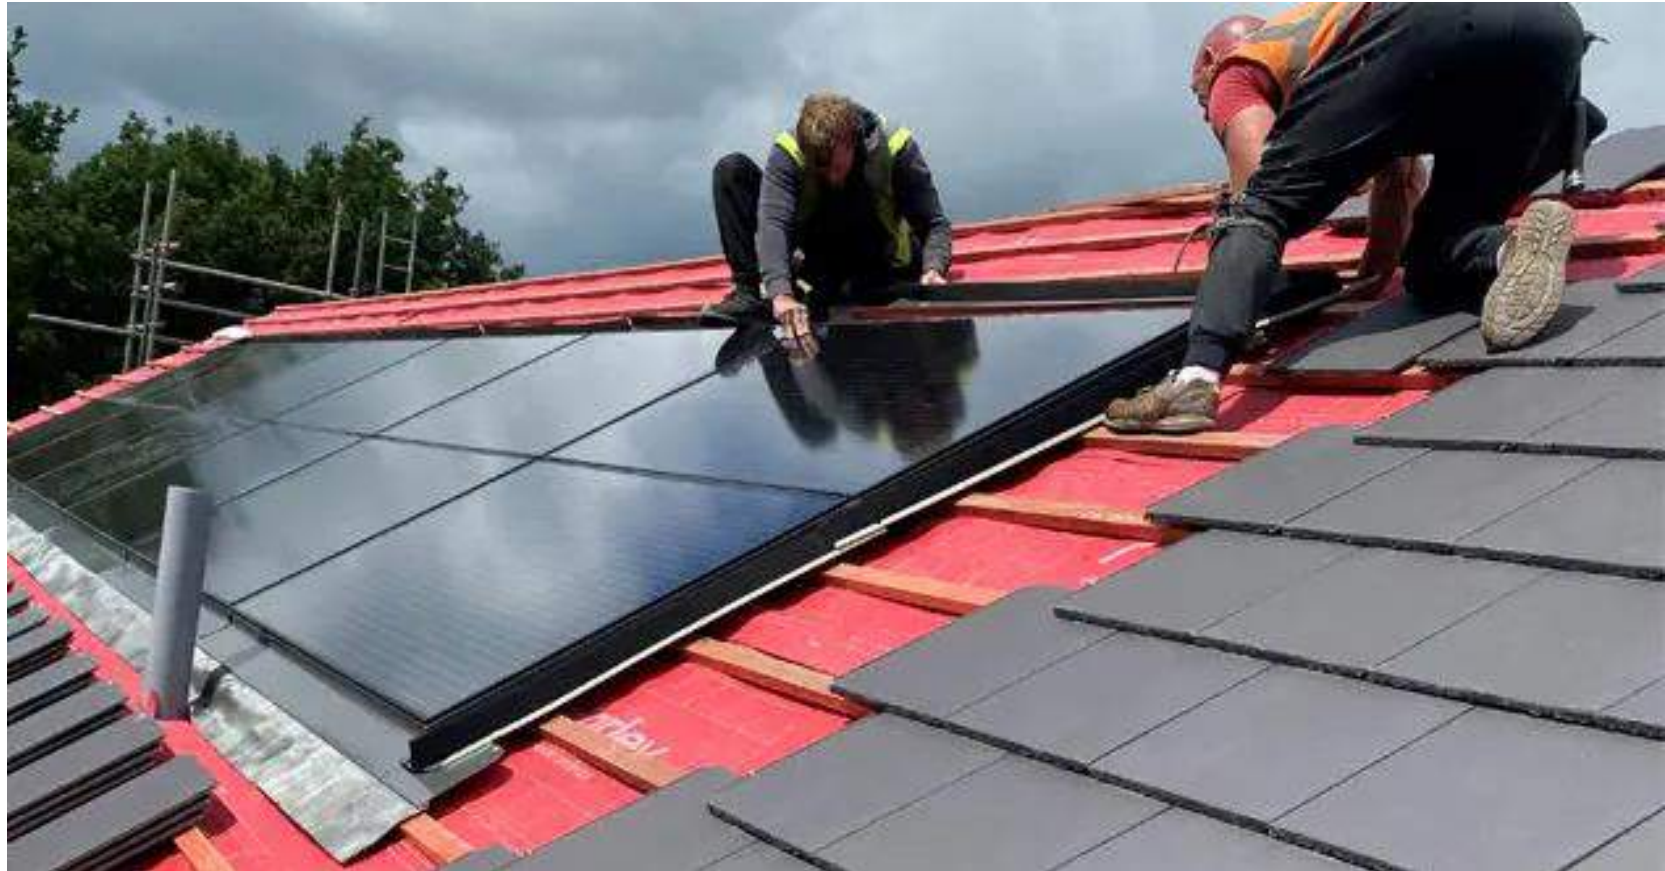
Sequence

- Not roofing contractors
- Not trained for working at height
- Delay in installation contrary to BS 5534 and BS 8000 part 6

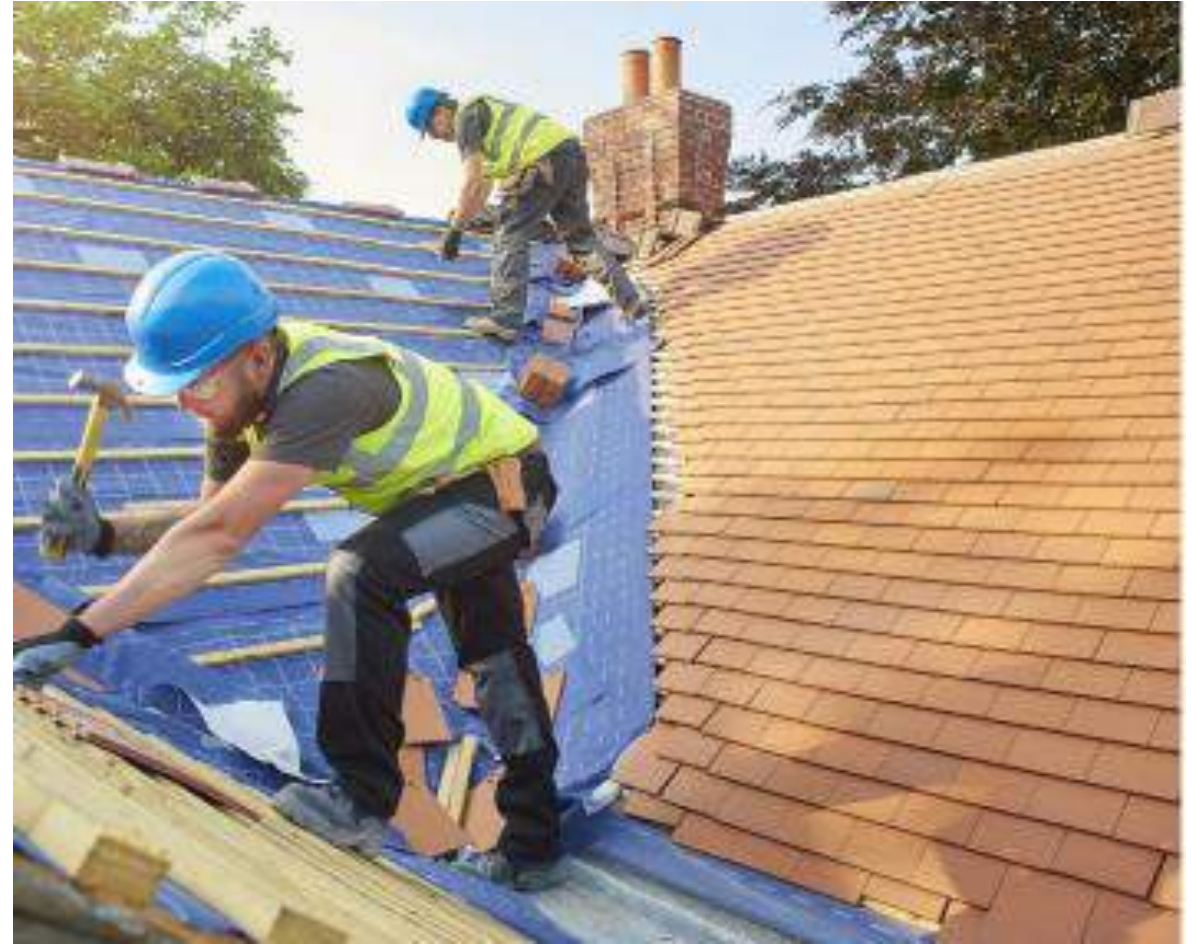
HSG33 Update: Slated and Tiled (pitched) Roofs

- Walking on the laid roof covering should be avoided;
- Reduce foot traffic on the finished roof;
- On most sloping roofs, suitable roof ladders or crawling boards will be essential;

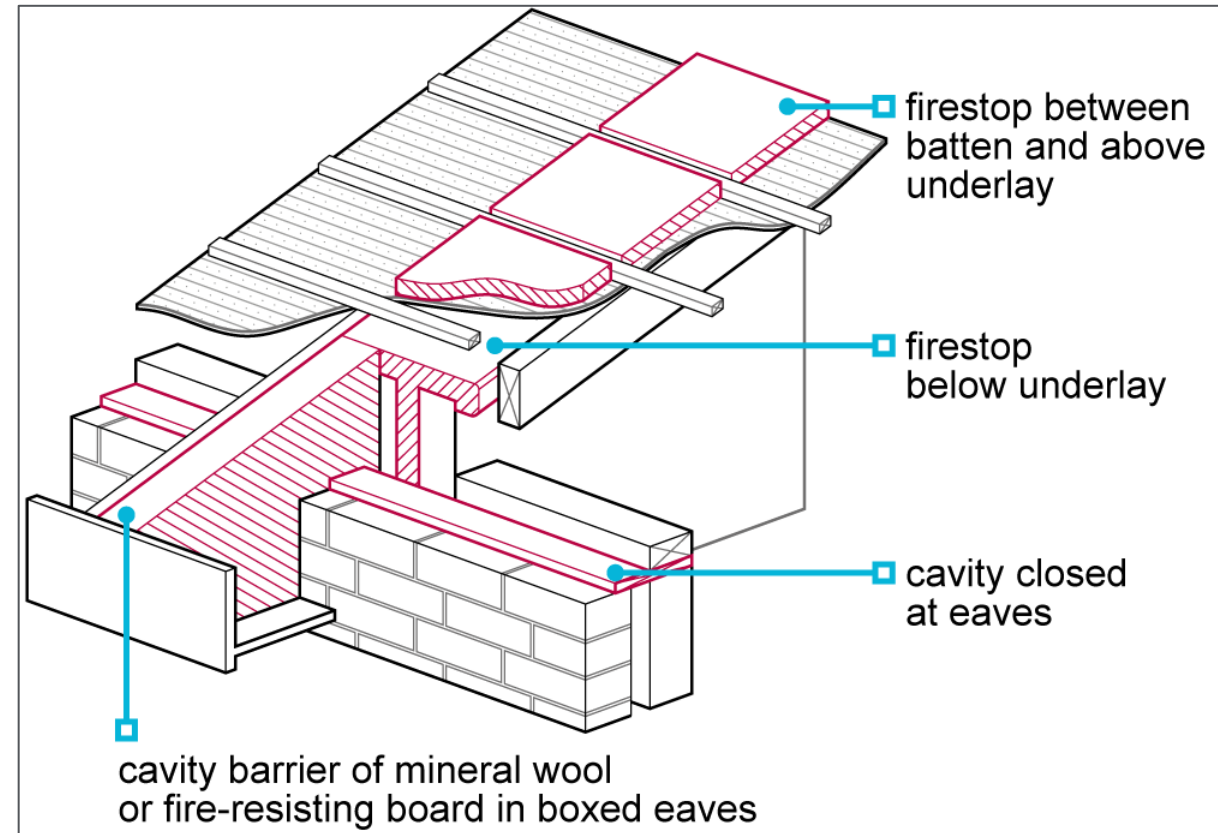
Firestop to Party and Compartment Walls

- The space between the top of a party or compartmental wall and the slates or tiles should be completely filled with a fire topping material above and below the underlay to fill all gaps.
- Packing should be compressed by the slates or tiles.
- There should be no path for smoke or flame to penetrate from one side of the wall to the other.
- Fire protection should extend into any void, such as boxed eaves.
