Safety Alert/ Bulletin

Subject: Vacuum Excavator

Description of Accident/ Incident

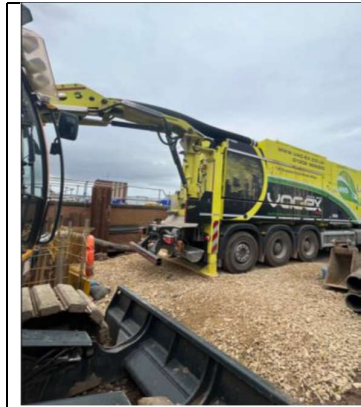
Vacuum Excavator

As he was bending down the powered suction hose moved towards him immediately removing his hard hat and forcibly drawing his head to the hose.

- Always keep clear from the suction hose. Always keep the hose as close as possible to the ground.
- If the hose needs to be raised the suction lines should be isolated
- Ensure clear communication between the operator of the machine and all employees within the excavation to ensure the agreed system of work is understood by everyone.

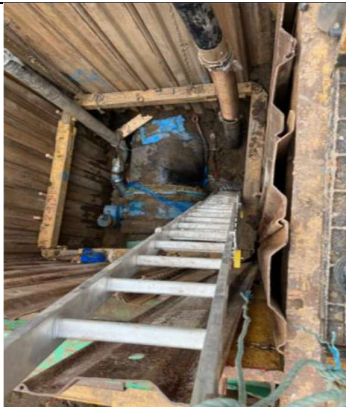
Deep excavation

The employee was within an eight-metre-deep excavation breaking up the ground and a colleague positioned the Vac Excavator hose over the ground to remove the spoil from the excavation.

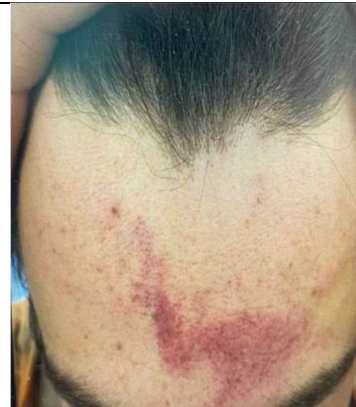
Head Injury

The employee did not receive serious injury but suffered abrasion and bruising to his forehead.
