## Safety Alert/ Bulletin

### Subject: Piling Rigs/ Concrete Pumps

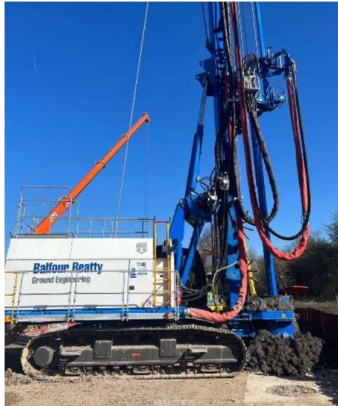
Casagrande Piling Rig

- All equipment identified in the safe system of work is on site and in good condition.
- Hoses, pipes, joint clips and restraint wires (whip check) have been checked and are suitable for use.

- Hoses are clearly identifiable with a serial number and inspected in accordance with the required maintenance regime.
- The safe systems of work for pumping, pipe and hose cleaning, and dealing with blockages, have been briefed to the whole team involved in the operations, including the requirement to stop work and report any blockages that may occur to the supervisor.

- Only competent operatives are authorised to operate concrete pumps and air compressors.
- An exclusion zone is in place when pumping and cleaning operations are in progress.

- A Permit to Pump Concrete is in place before concreting operations begin.
- Measures ensuring that only concrete that is within its curing time limit is used.

- Regular monitoring to ensure these control measures remain in place.
